Historic Furnishings Report

EXTERIOR FURNISHINGS OF LOWER TOWN HARPERS FERRY

HARPERS FERRY
National Historical Park/West Virginia

Division of Historic Furnishings
Harpers Ferry Center
National Park Service
1995

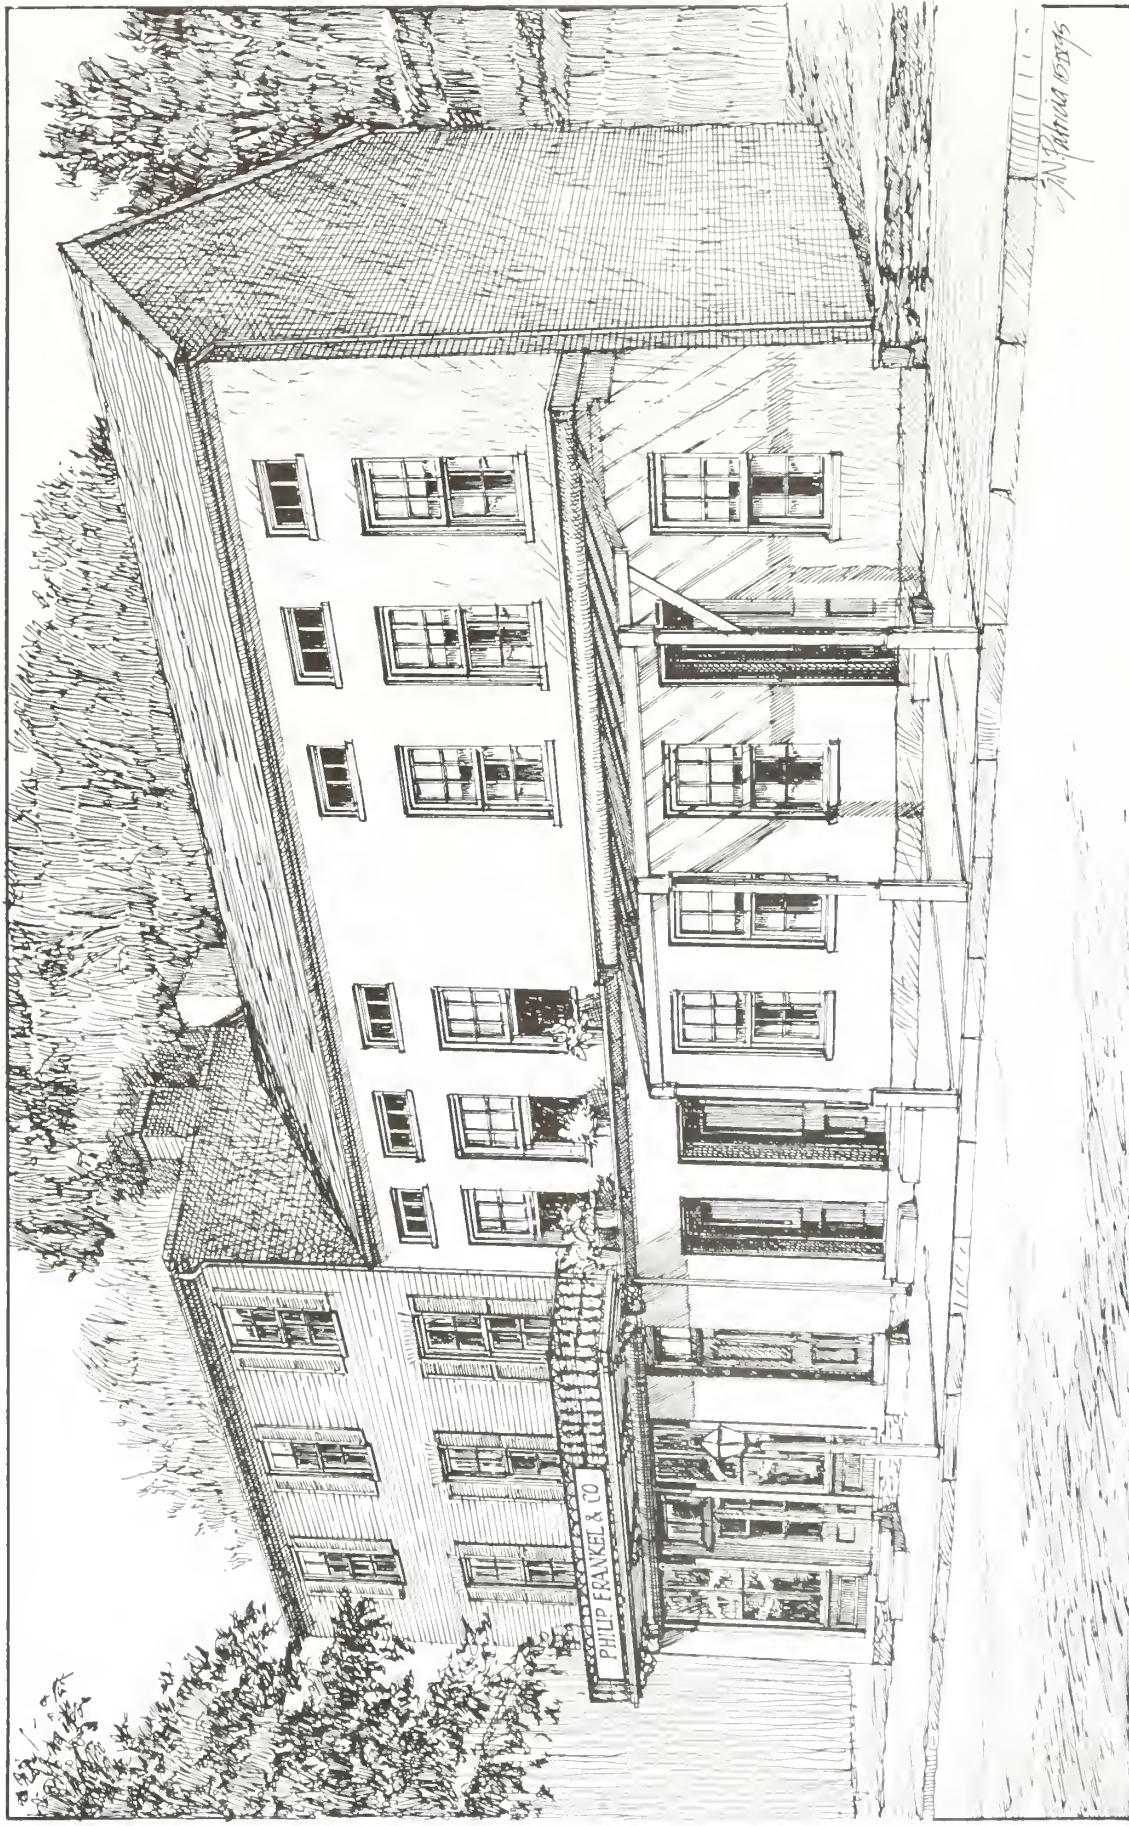
West Side of Shenandoah Street, South of High Street: Buildings 48, 45, 44, 43, 40, 38

Object and Location	Documentation	Recommendation and Installation Consideration
<p>WINDOW TREATMENTS</p> <p><u>Building 48</u></p> <p>First floor: 6 roller shades with full length, double panel curtains</p> <p>Second floor: 1 roller shade and 6 short-style curtains</p>	<p>Rented by an armorer and family in 1859.</p>	<p>Year round park residence. Reproduce. Storage of park materials should be moved away from the windows so it is not visible from the street.</p>
<p>WINDOW TREATMENTS</p> <p><u>Building 45</u></p> <p>Second floor: 6 roller shades with tassels and full length, double panel curtains; 3 rollers shades</p> <p>Third floor: 2 short style curtains, 2 empty</p>	<p>Upper floors rented to two families in 1859.</p>	<p>Reproduce. Storage of park materials should be moved away from the windows so it is not visible from the street.</p>
<p>CHAIRS, 4, rod-back and captain's style (on second floor porch of building 45)</p>	<p>"An adjourn to the porch [of Stipes' boarding house] follows the repast, when conversation supervenes," <i>The James E. Taylor Sketchbook</i>, p. 37.</p>	<p>Reproduce.</p>

<p>CHAIRS, 2, rod-back and captain's styles (on second and third floor porches of building 43)</p>	<p>"An adjourn to the porch [of Stipes' boarding house] follows the repast, when conversation supervenes," <i>The James E. Taylor Sketchbook</i>, p. 37.</p>	<p>Reproduce.</p>

AWNING and FRAME, on building 40	Stores containing window clothing displays often had awnings to protect their merchandise from damage caused by heat and sunlight. Figure 15 shows numerous awnings on buildings along this side of Shenandoah Street.	Reproduce.
AWNING and FRAME, on building 38	Figures 5, 9, and 10.	Reproduce. Interior lighting must be added for archeology exhibition since awning will obstruct natural light in the exhibition.
WOOD PILE, approx. 2 ft. long and 1/2 ft. high (on second floor back porch of building 38)	The upper floors of building 38 were dwellings. Both wood and coal were used to fuel stoves in Harpers Ferry in second half of the nineteenth century.	Acquire cut wood.
BARRELS, 2, and BENCH (behind building 38)	Half of building 38 contained a grocery in 1859.	Reproduce.
FLOWER POTS with geraniums (on ledge of building 38, left side below second floor window sills)	Figure 5.	Reproduce.

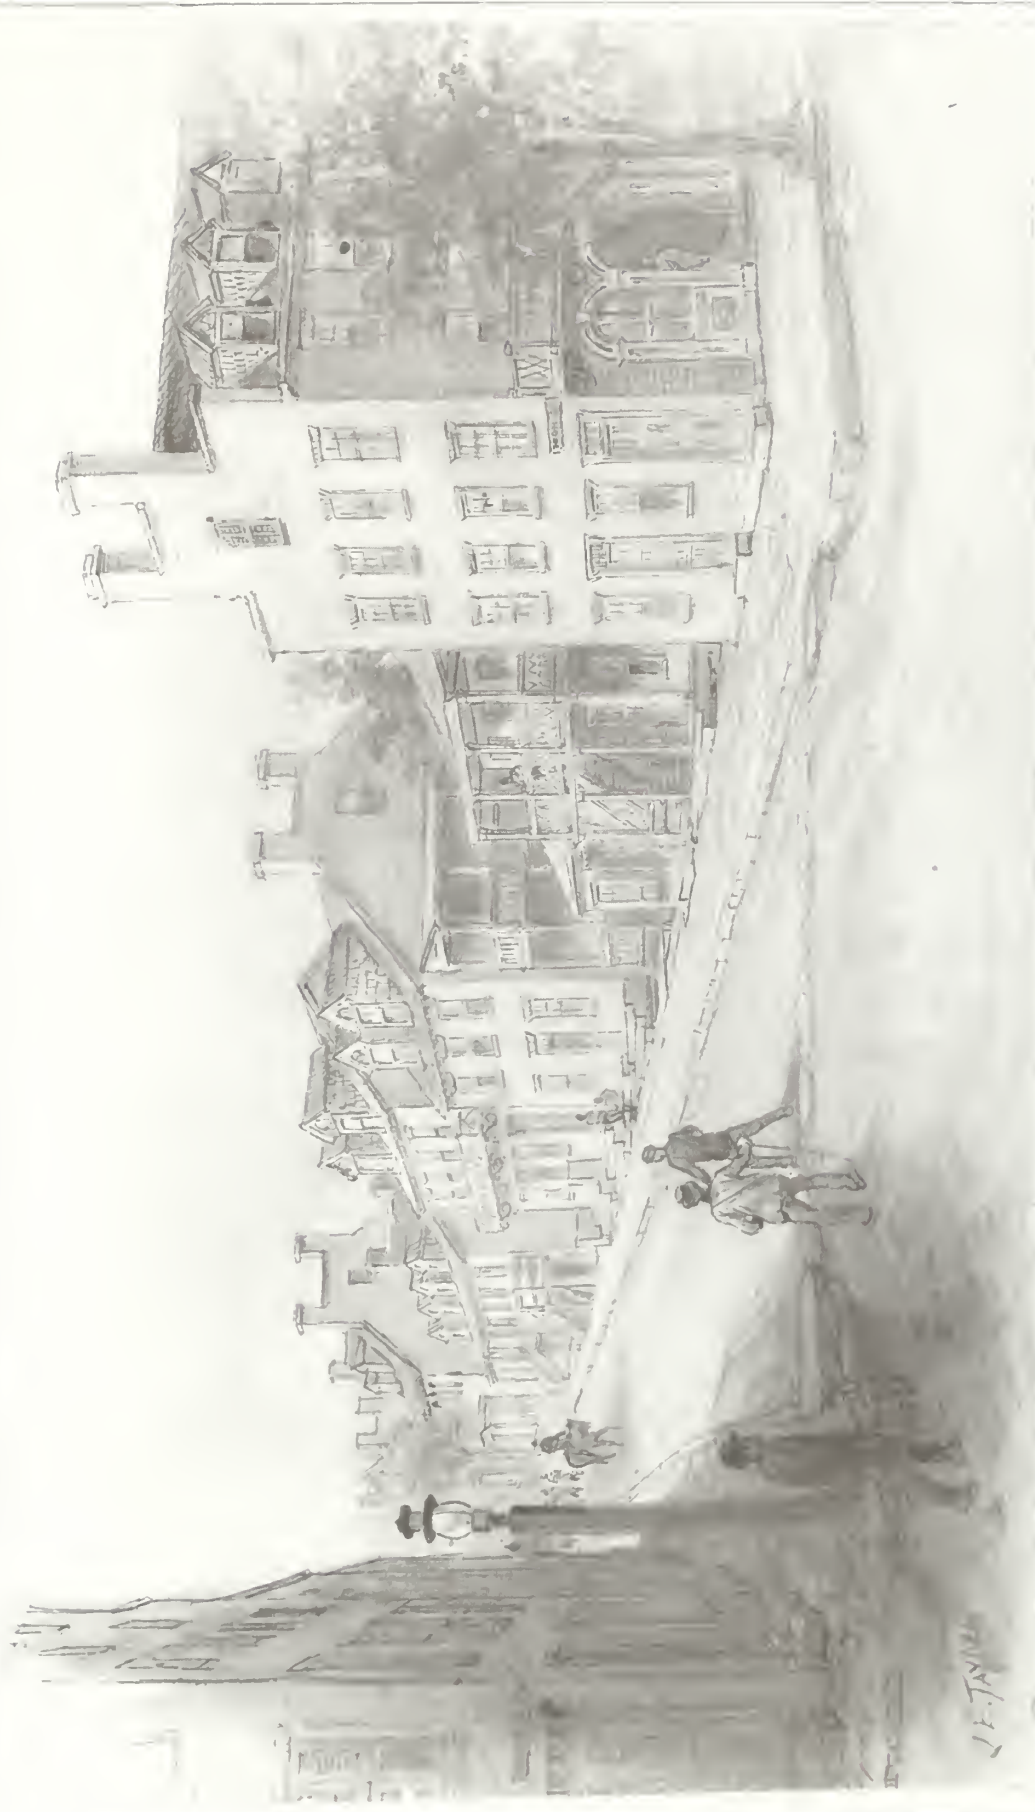
Figure 2. *View of High Street from Shenandoah Street - leading to the Valley Pike*, by James E. Taylor, 1864. From *The James E. Taylor Sketchbook*. Courtesy of the Western Reserve Historical Society.

Object and Location	Documentation	Recommendation and Installation Consideration
STREET LIGHTS, 4 (one on corner of Shenandoah and High St., west side; one in front of building 9; one in front of building 43; and one in front of building 7)	Figures 2 and 9.	Reproduce and replace existing lights at these locations.
WELL PUMP (on south side of Shenandoah Street, just west of Rock Alley)	Figure 17.	Reproduce.
TREE PROTECTORS (around any smaller trees up to about 15 ft. tall)	Figure 6.	Reproduce from scrap wood.

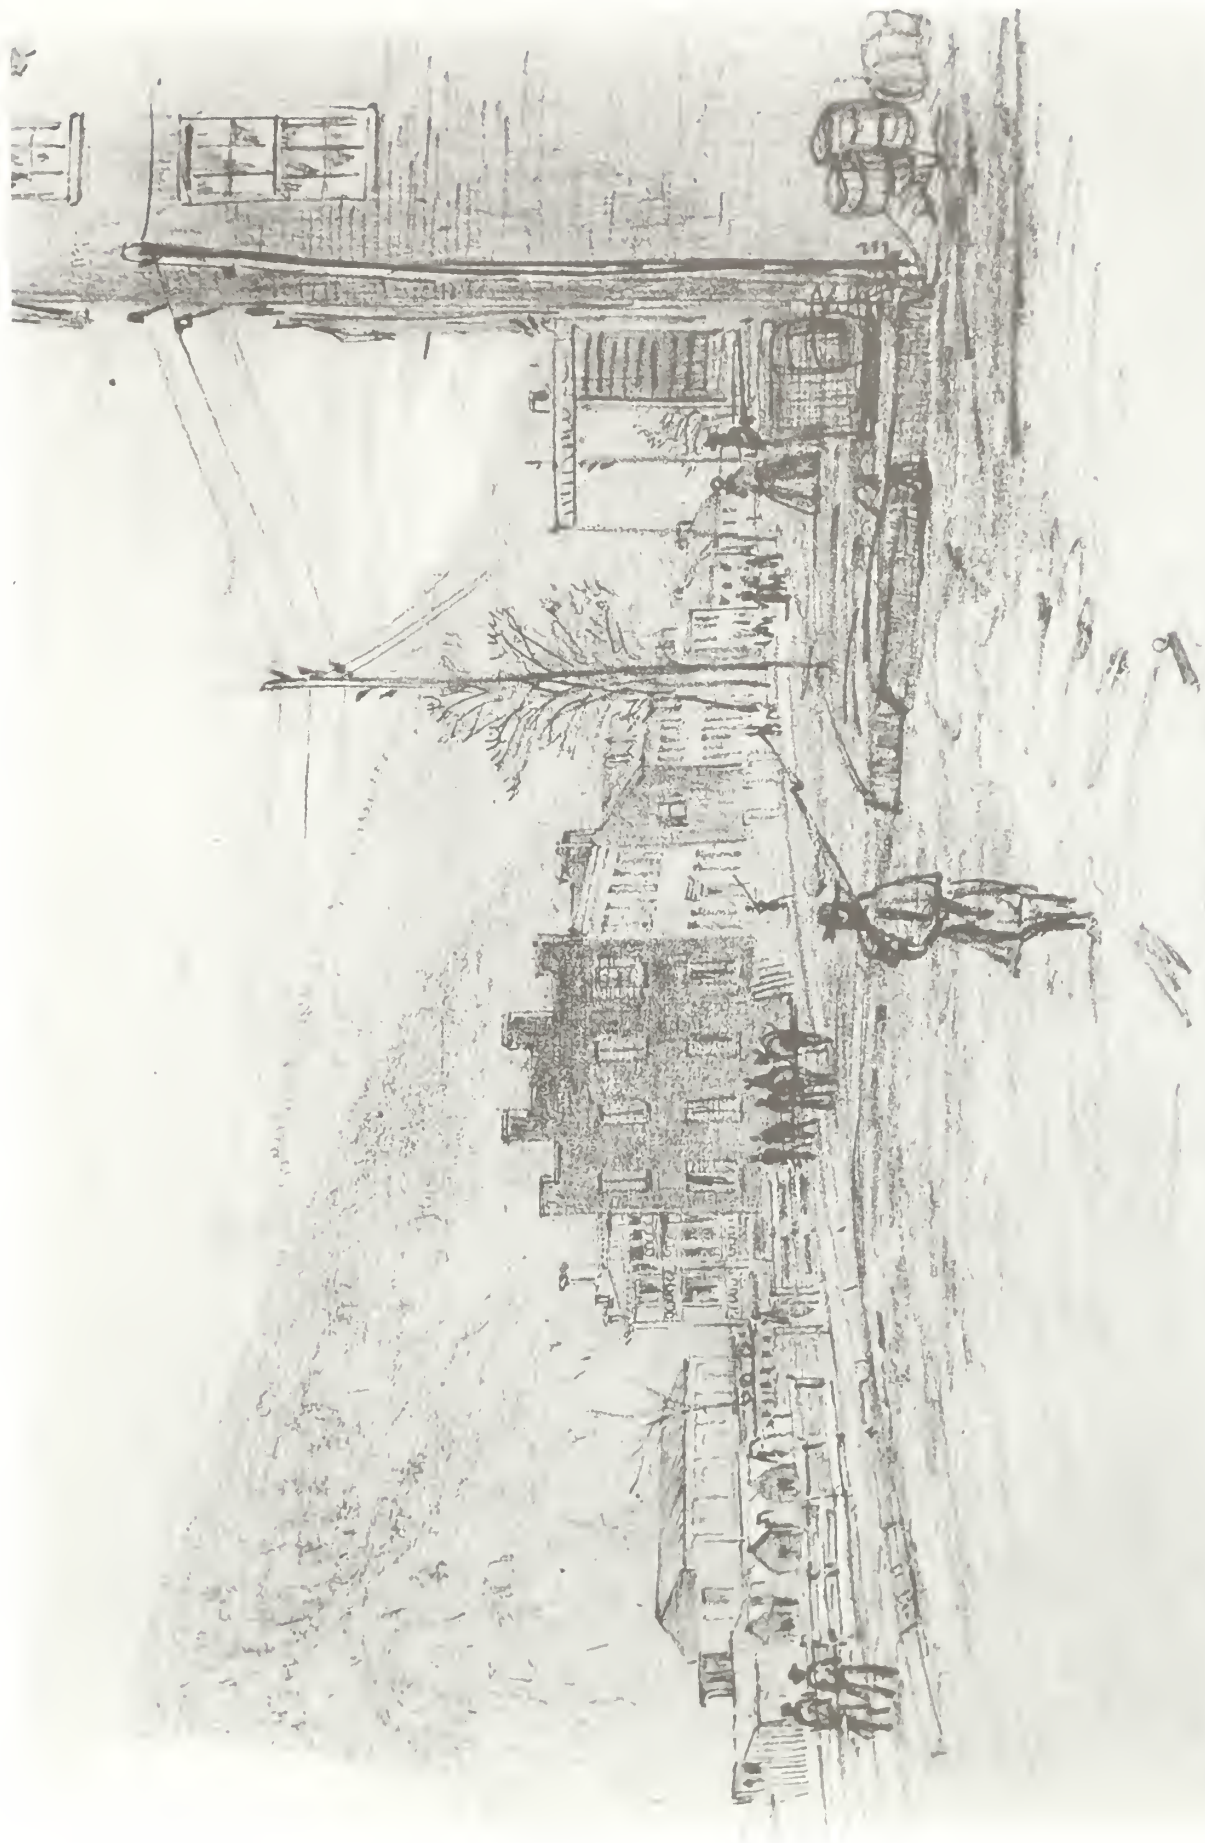
Figure 3. *General Stevenson's Headquarters, Harpers Ferry*, by A.R. Waud.
Neg. no HF-224. This is a view of Shenandoah Street from Potomac
Street, 1865. Courtesy of the Library of Congress.

POTTED GERANIUMS (on sill of window on second floor of building 9, on Potomac Street side)	Figure 12.	Reproduce. Use artificial flowers that will be replaced annually.
BARRELS, 4 (on corner of Shenandoah and Potomac streets, beside building 9)	Figure 3.	Reproduce.
SIGN, <i>DRUGGIST</i> (between first and second floor windows of building 9)	Building 9 contained a store of unknown type in 1859. From 1845-1855 it was a drug store.	Reproduce.
WELL PUMP (where pump is currently located)	Figure 11.	Reproduce and paint.

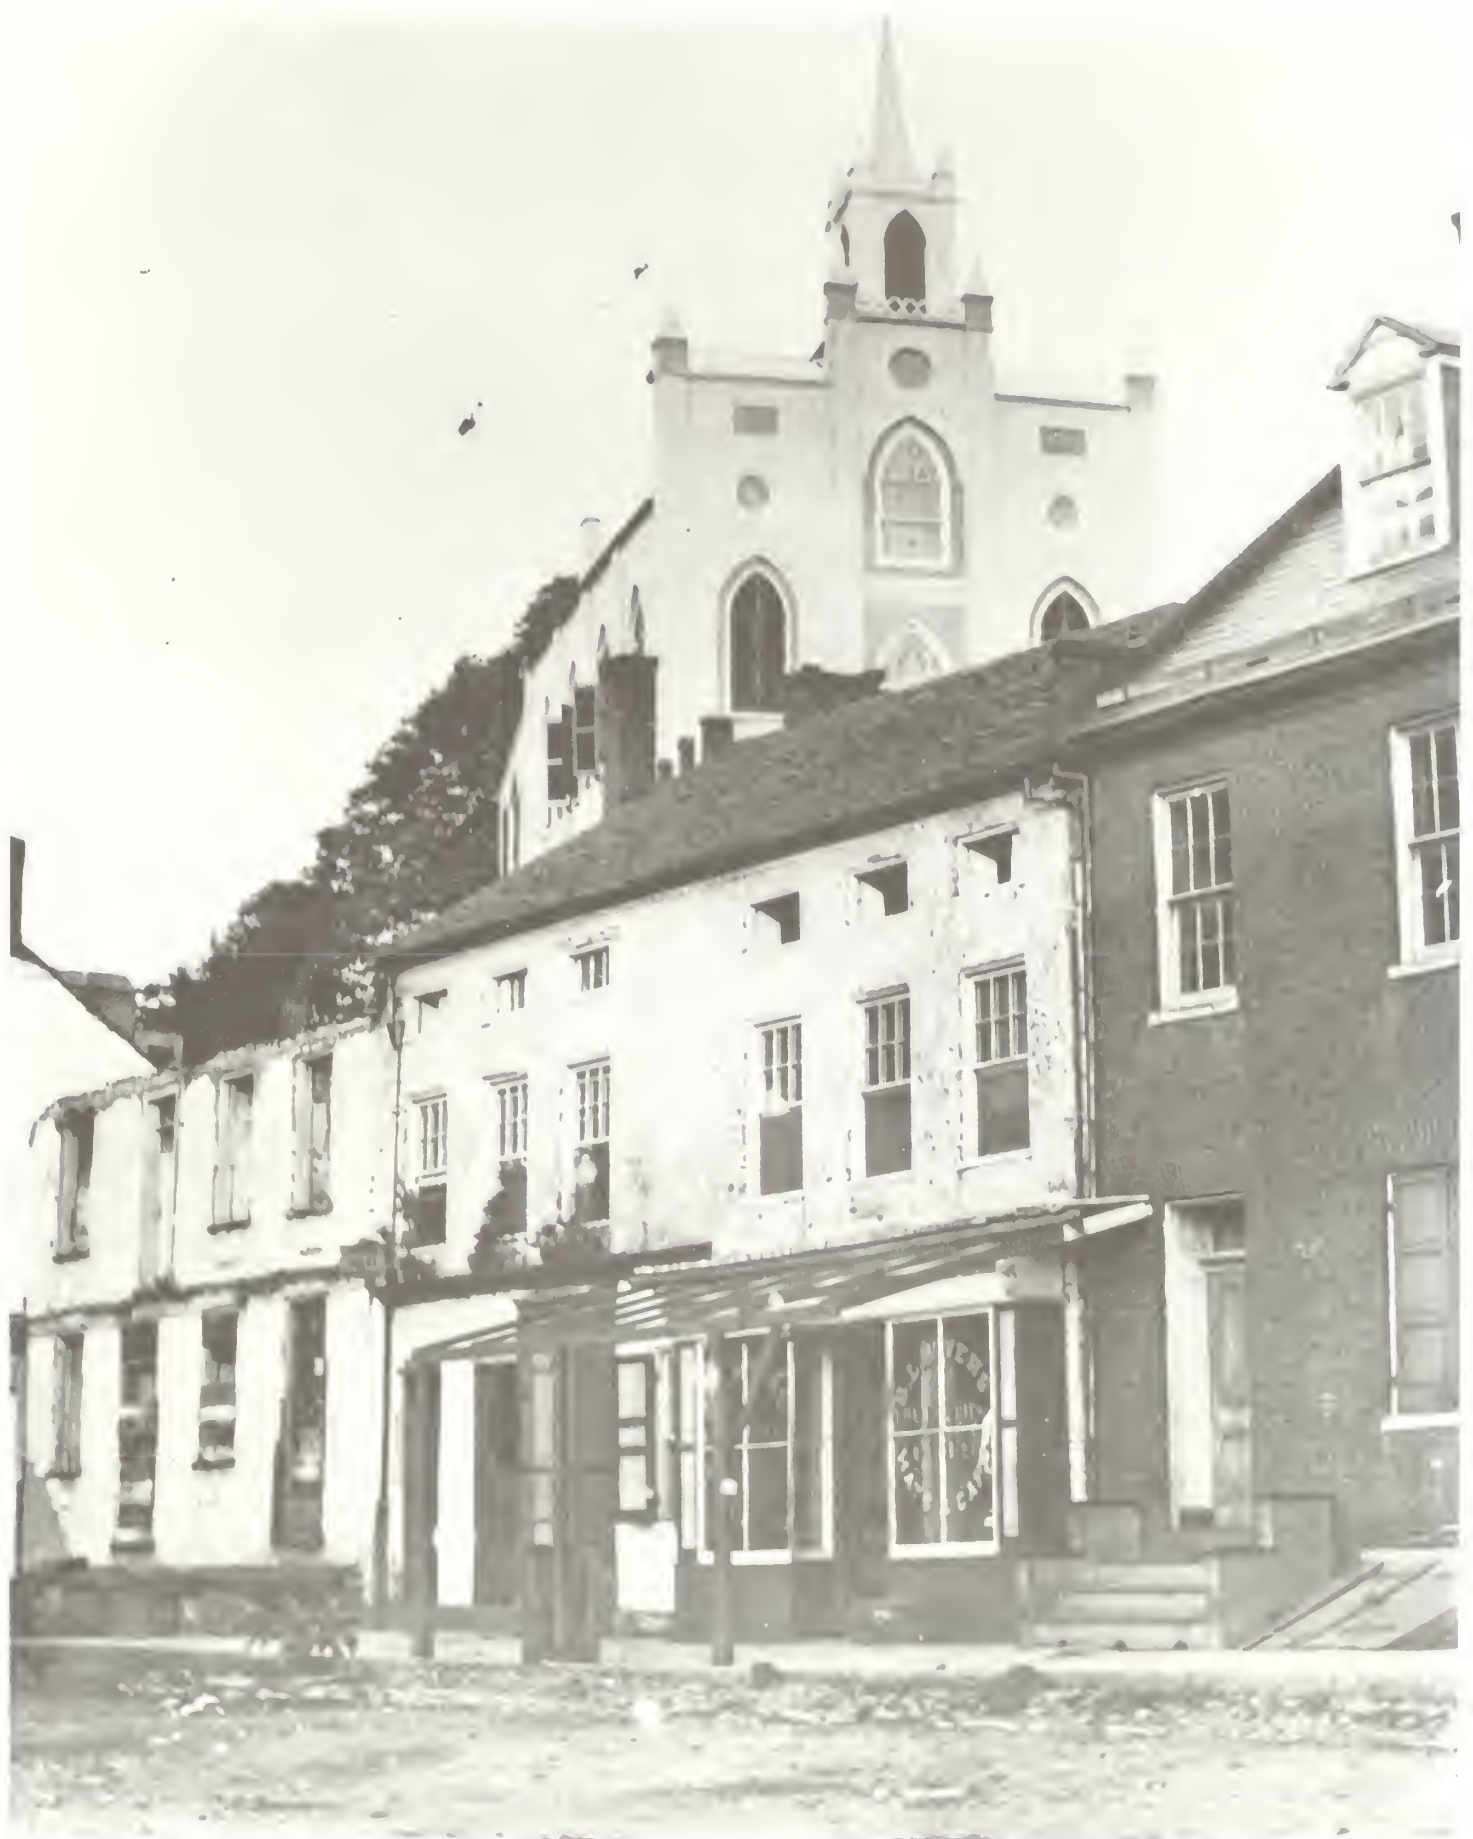
Figure 5. Shenandoah Street, ca.1865-81. The front of buildings 38 and 40, and the side of building 43 can be seen. The brick building on the right is no longer standing. Neg. no. HF-35. Courtesy of Harpers Ferry National Historical Park library.

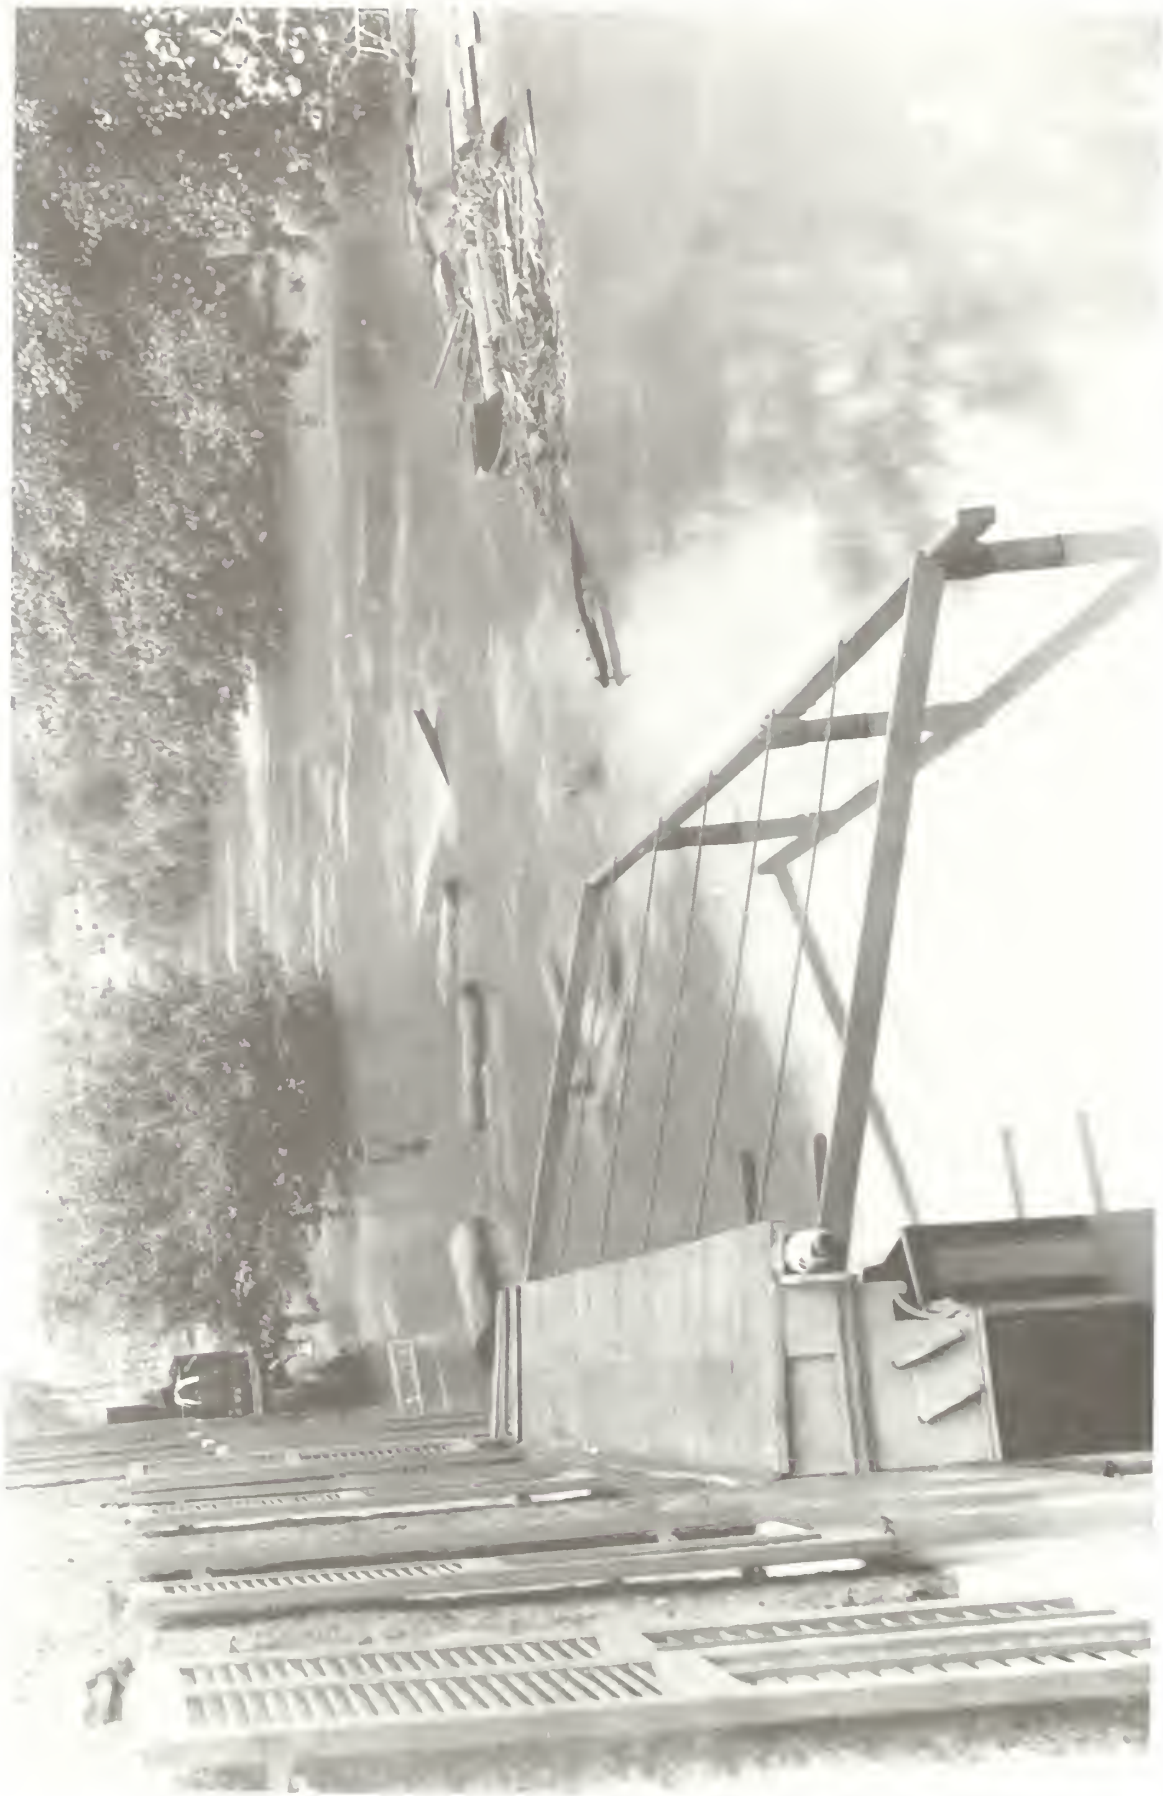
Figure 10. East Shenandoah Street during the flood of 1889. Awning frame on building 38 is the same one shown in figure 9. Neg. no. HF-610. Courtesy of Harpers Ferry National Historical Park library.

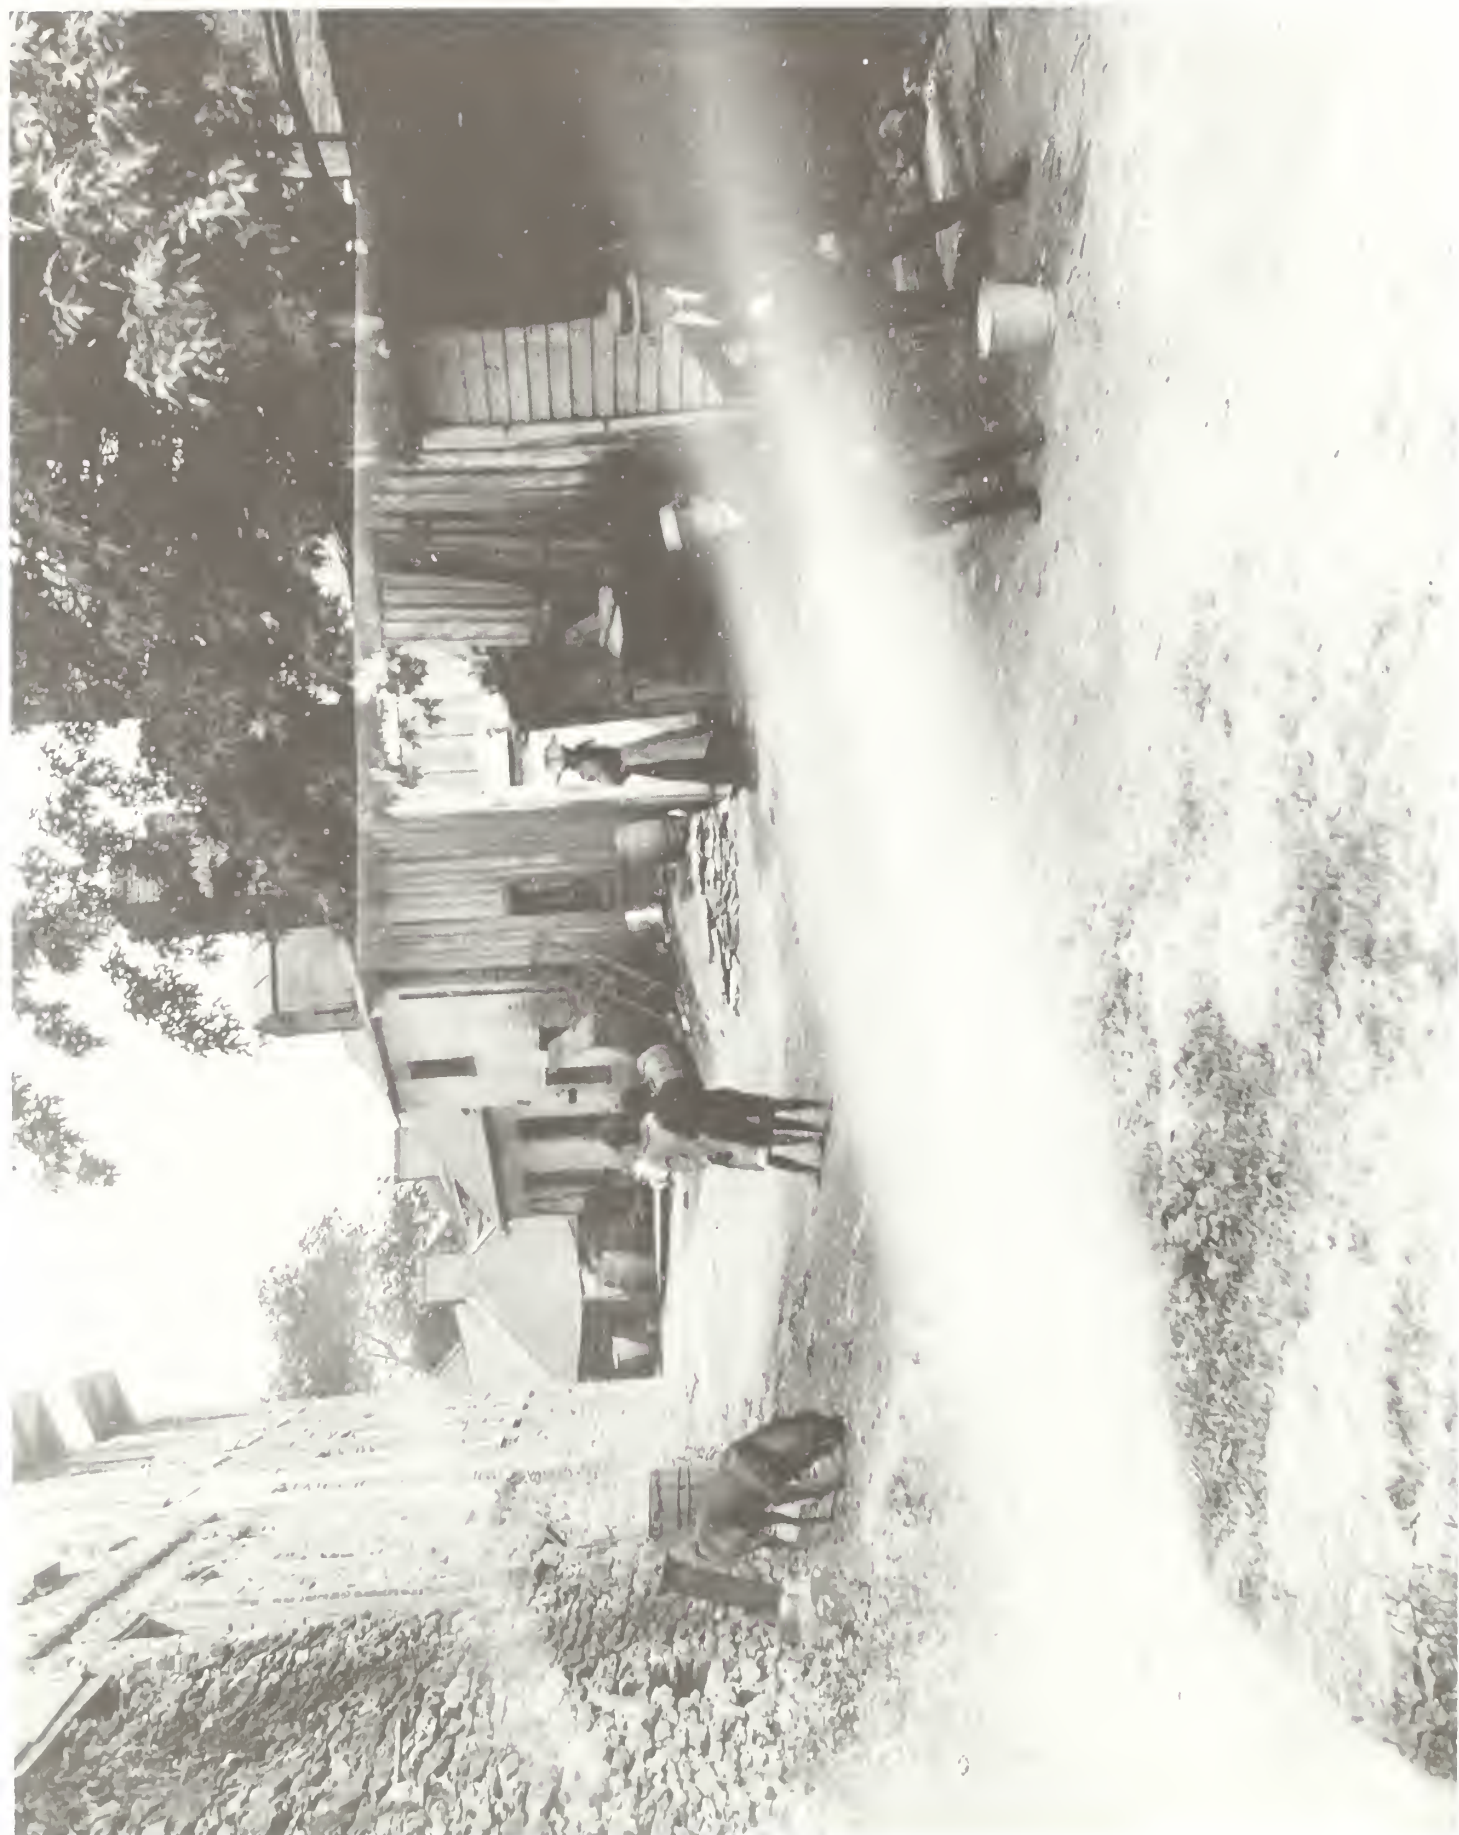
Figure 13. Marmion Row and the lower Public Walk, 1890s. The buildings on the right side of the walk are not extant. Neg. no. HF-1733. Courtesy of Harpers Ferry National Historical Park library.

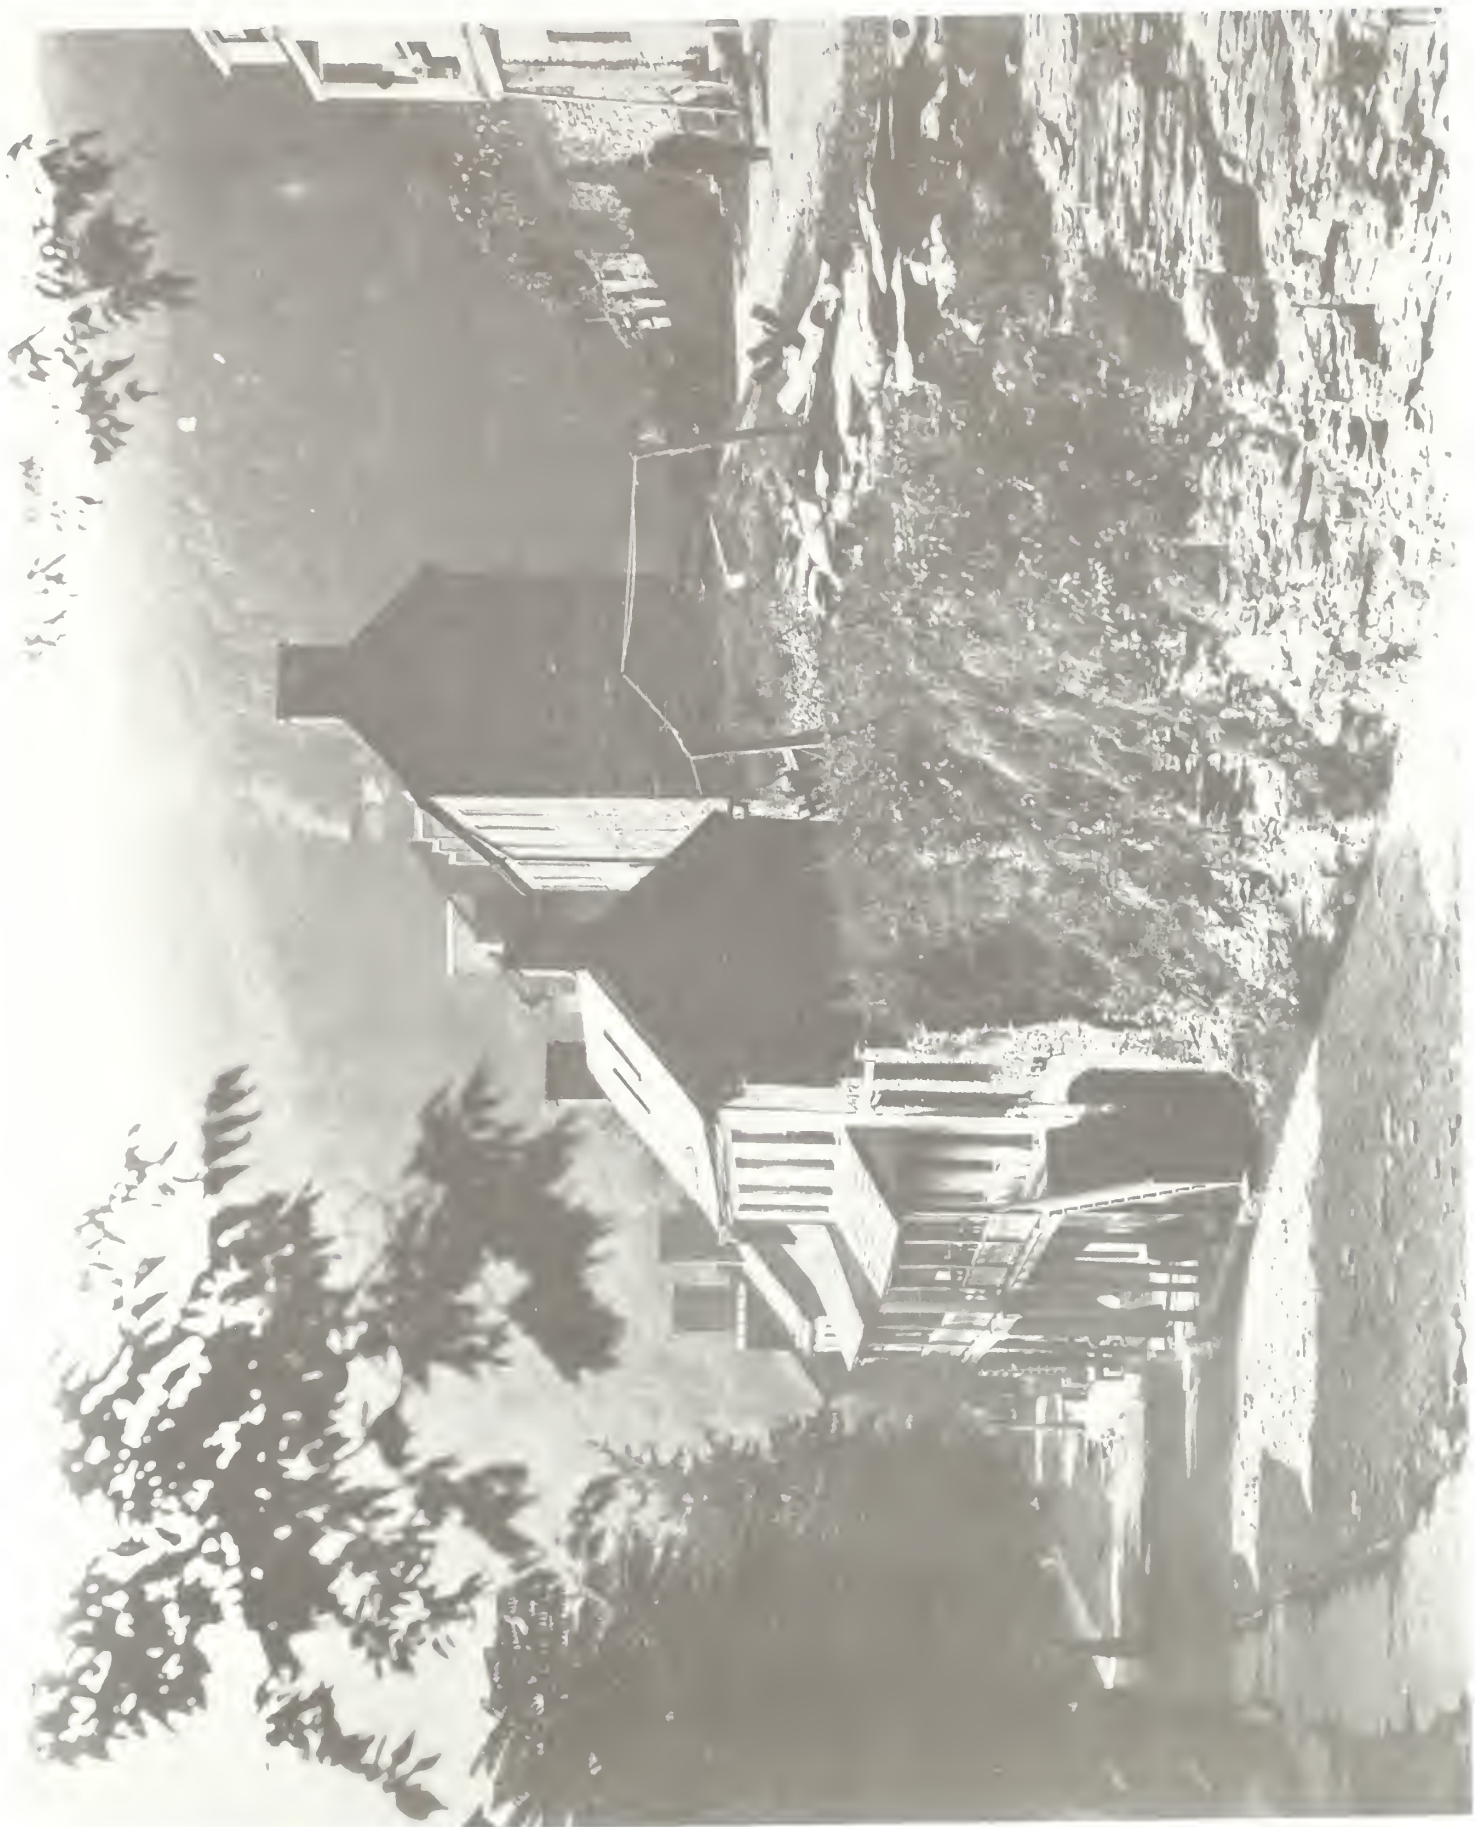
Figure 17. Shenandoah Street, looking west, 1898. Neg. no. HF 1799. Courtesy of Harpers Ferry National Historical Park library.

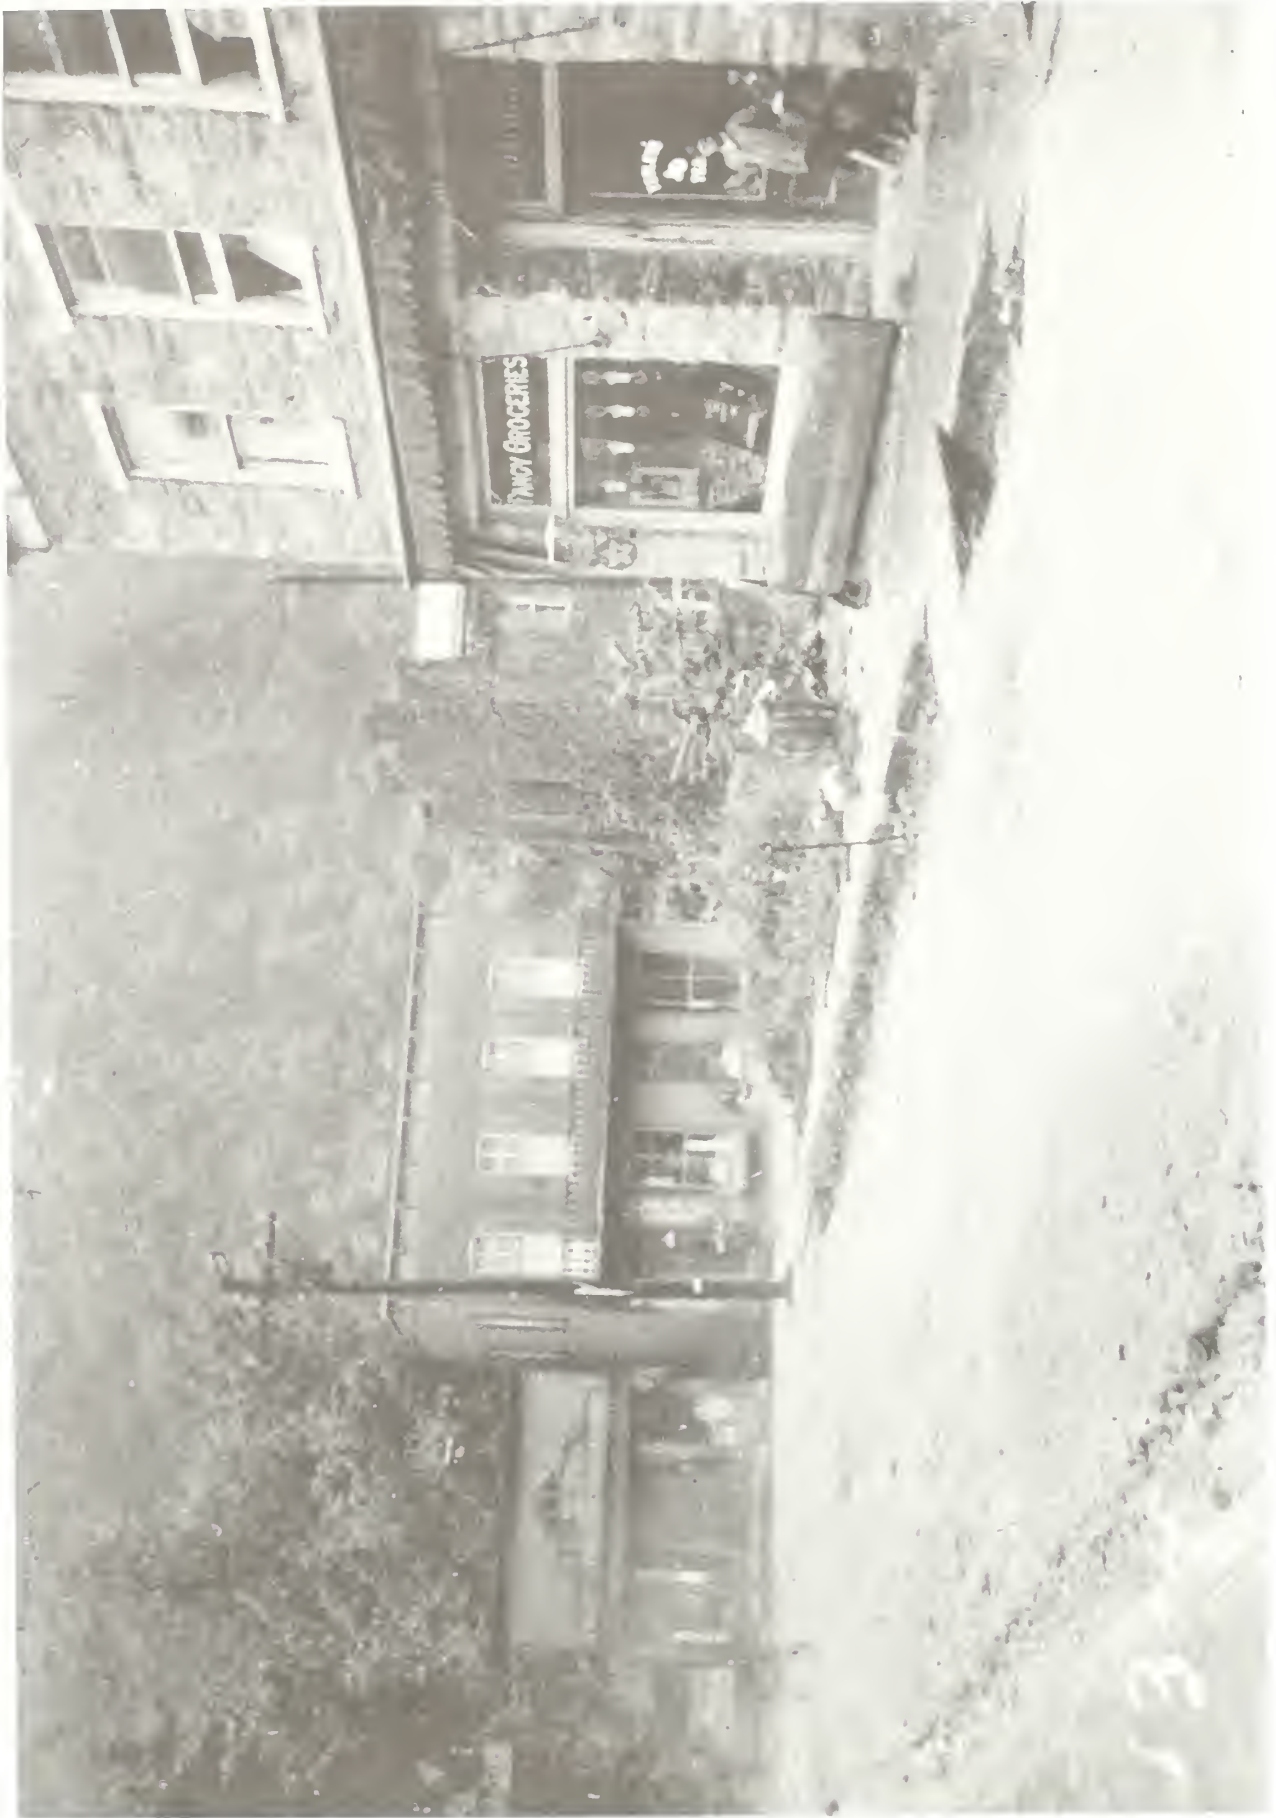
Figure 19. A view of High and Shenandoah Streets, 1915-1920. Neg. no. HF-1861. Courtesy of the Harpers Ferry National Historical Park library.

Object and Location	Documentation	Recommendation and Installation Consideration
AWNING (retracted against facade of building 37)	Figure 19. Leo O'Beirne's store occupied the building from 1914-1928.	Reproduce.
WOOD PILE, approx. 2-1/2 ft. long and 1-1/2 ft. high (on second floor back porch of building 16)	Frederick A. Roeder and his family lived here in 1859. Both wood and coal were used to fuel stoves in Harpers Ferry in the second half of the nineteenth century.	Acquire cut wood.
<p>WINDOW TREATMENTS</p> <p><u>Building 16</u></p> <p>Basement: 2 short style curtains by porch</p> <p>Second floor: 4 full length, double panel calico curtains, right front room; 1 short style curtain, left front room; 2 short style curtains, rear room</p>	Frederick A. Roeder and his family lived here in 1859; Gibson estate (see note, p. 17).	Reproduce. Storage of park materials should be moved away from the windows so it is not visible from the street.

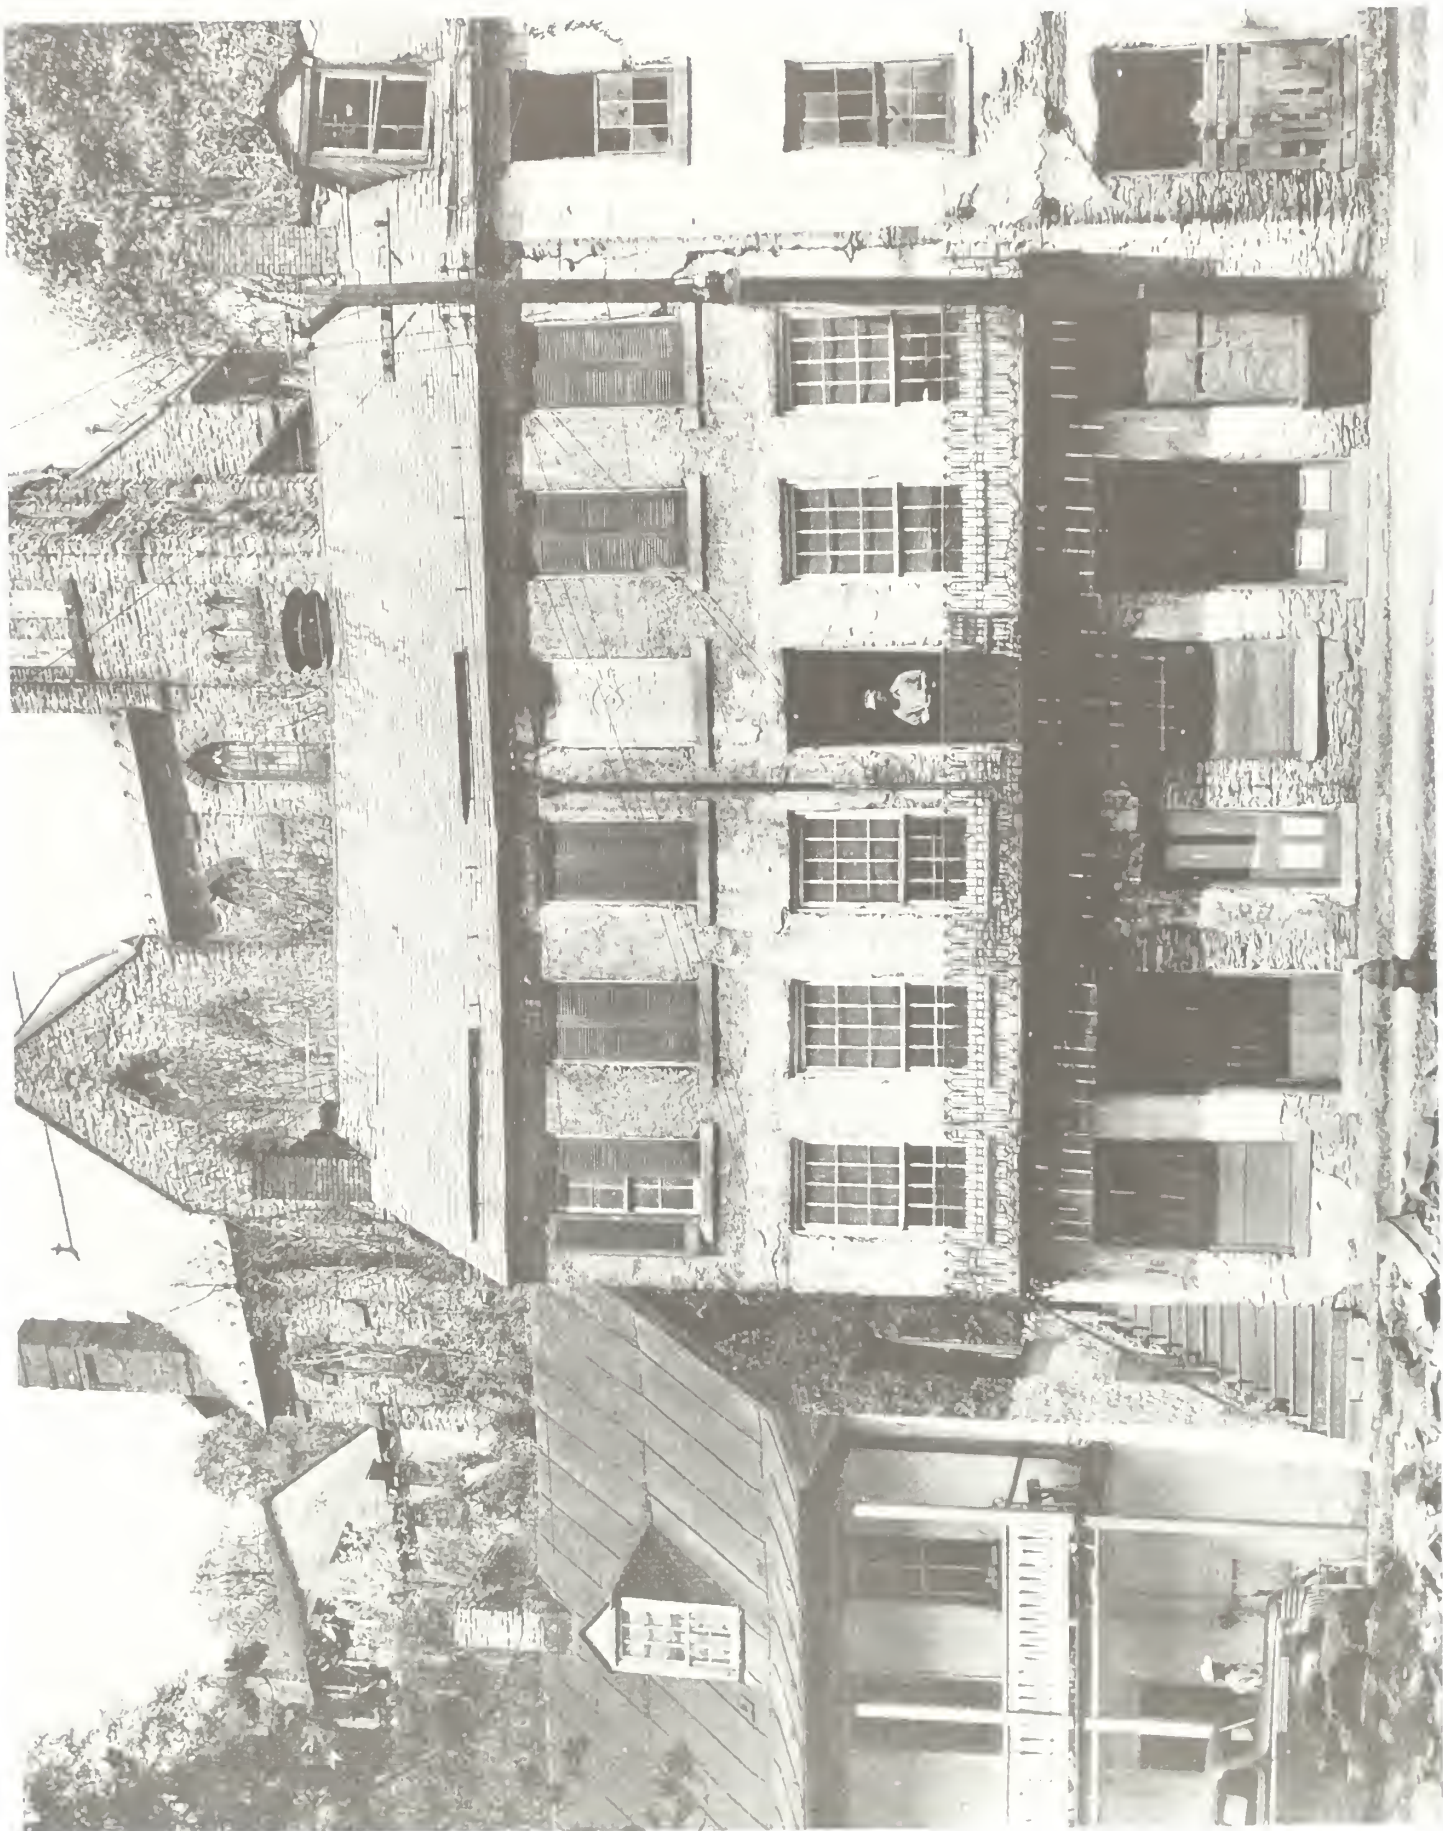
Figure 20. Masonic Hall, Shenandoah Street, ca.1940s. Courtesy of the Masonic Lodge, Harpers Ferry, West Virginia.

<p>MASONIC PLAQUE (on third floor of building 44, 4th bay from west end)</p>	<p>Figure 20. The Masonic hall of Charity Lodge 111 was on the third floor of building 44. The plaque is now located in the fourth bay of the present Masonic meeting hall on Washington Street.</p>	<p>Reproduce.</p>
